# Public Realm, Walking and Cycling Strategy

## APPENDIX 4

**Old Oak & Park Royal Walking, Cycling, Streets and Public Realm Strategy: PERS audit**

April 2017

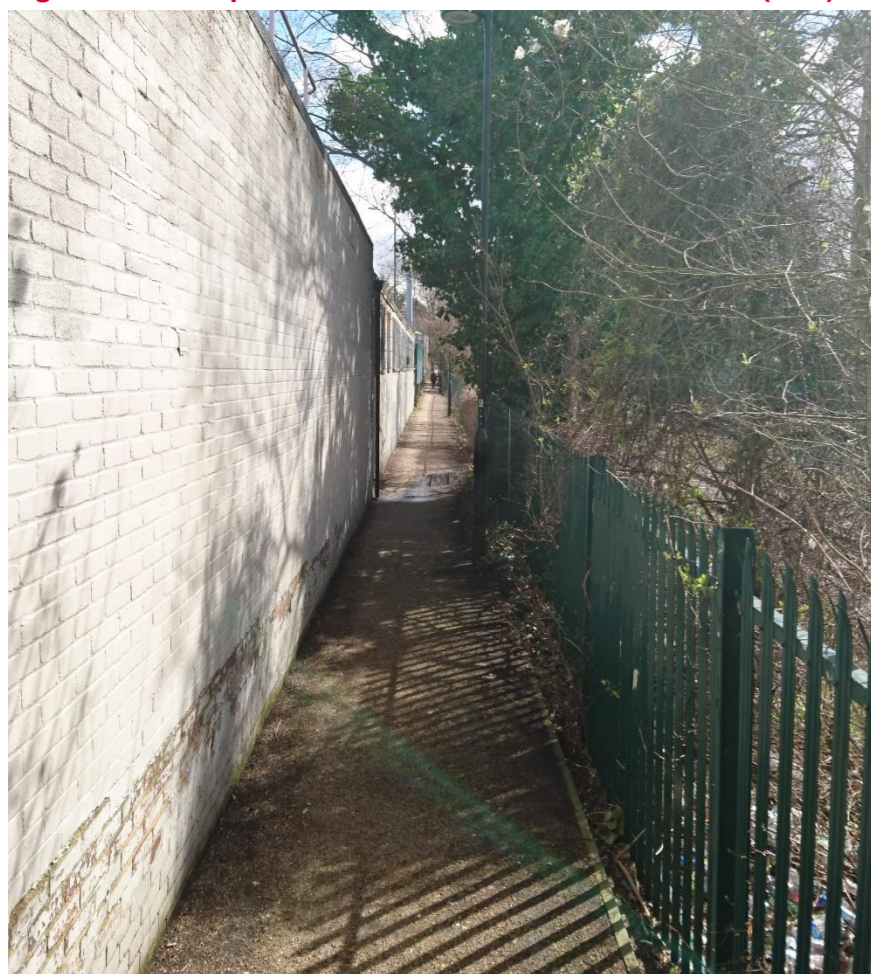
4.1.9 Furthermore, there are several key routes into the study area where pedestrians have large sections with no fronting or overlooking activity at all. These include the Stonebridge Park station link over the North Circular (R9a), the Park Royal station link (R8b and R10), the cemetery link between North Acton station and Park Royal Road (R9b), and the succession of railway tunnels on Old Oak Common lane (R6b).

**Figure 4-3: Footpath link towards North Acton station (R9b)**

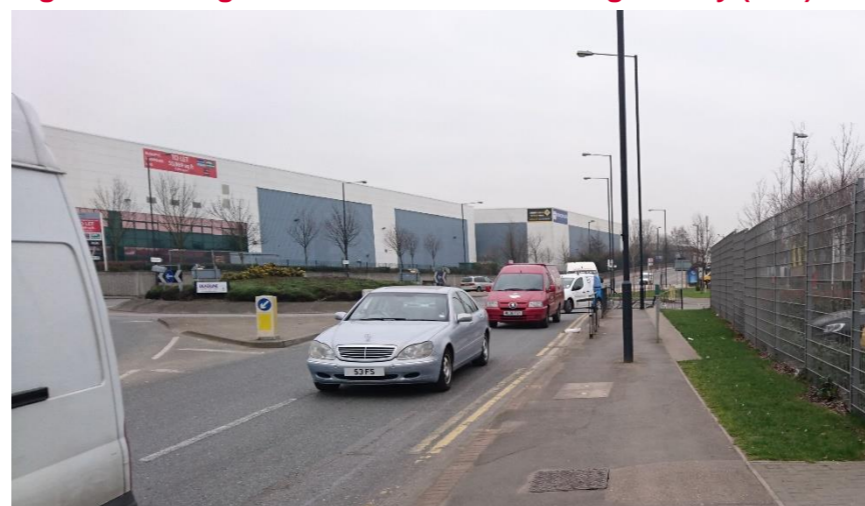
**Figure 4-4: Large units with no street-facing activity (R9a)**

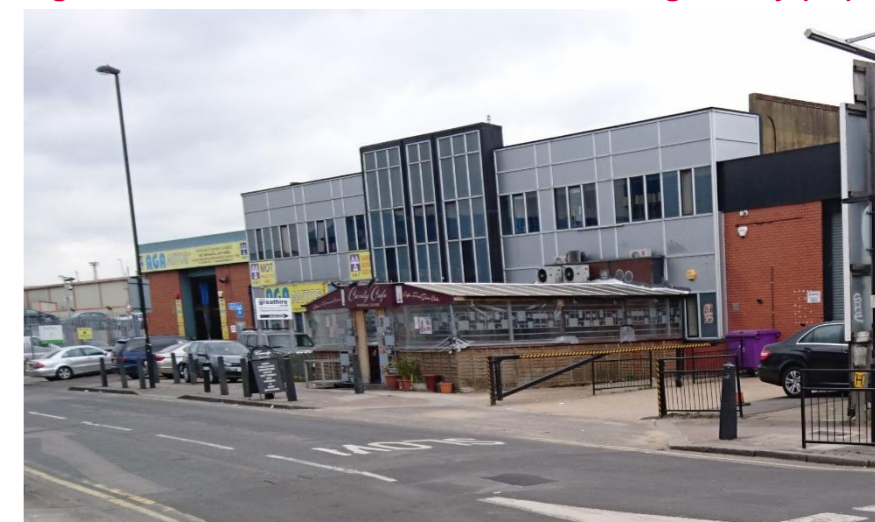
4.1.14 The perception of quality of the environment does depend on the nature of the industrial frontages though. In some areas with smaller unit sizes and some street-facing units there is more visual interest and the passer-by can catch glimpses of the adjacent places of work. Yet the more interesting environments are often those that generate the most conflict with pedestrians if they spill out onto the footway

**Figure 4-5: Smaller unit sizes with street-facing activity (R7)**

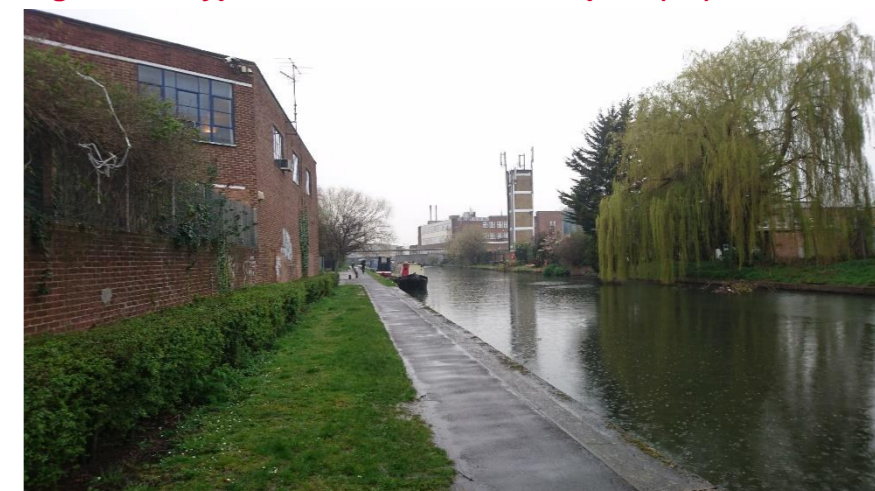
4.1.15 The canal towpath (R3) scores higher for quality of environment since it is a fascinating place combining nature, working industries, residential use of the canal boats and industrial heritage.

**Figure 4-6: Typical view of the canal towpath (R3)**

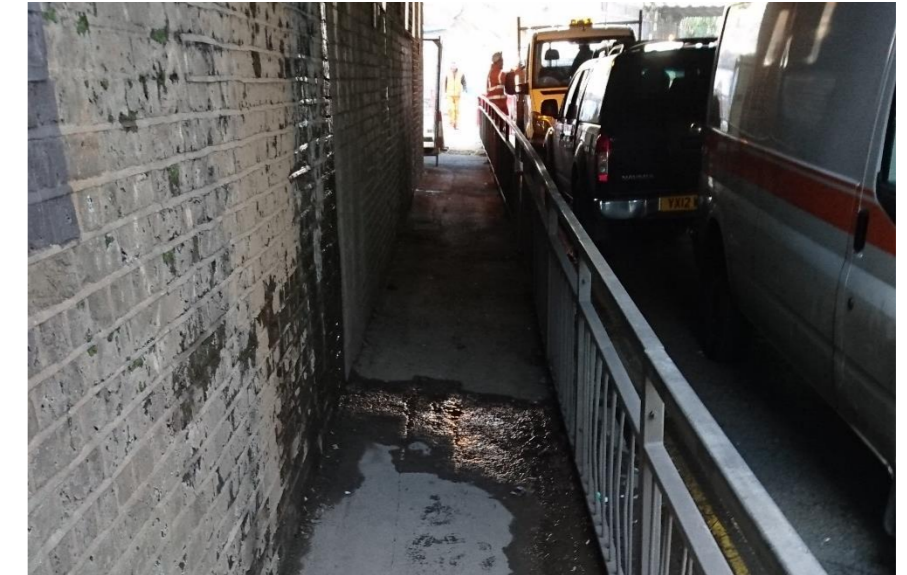
Figure 4-8: Narrow footways in railway tunnels (L17)

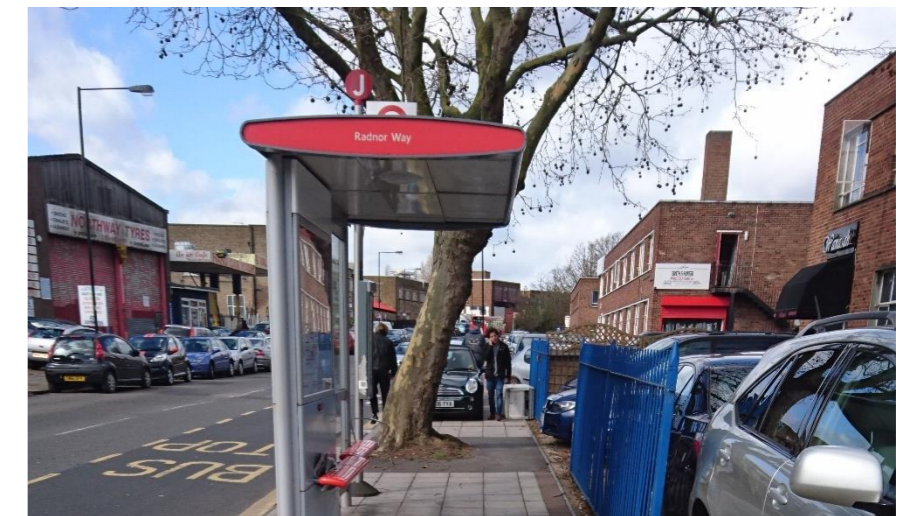
- 4.2.5 In most of the study area, the effective pedestrian space available is determined mainly by the positioning of obstructions in the footway. For example, it is not uncommon in this area that large road signs aimed at HGVs travelling at speed are mounted on two poles in the footway.
- 4.2.6 The blocking of footway space is most acute in several areas with a clustering of automotive related industries (L31, L24 and L27). The merging of workshop space and footway frequently leads to footways being blocked. While these are some of the more amenable pedestrian environments in Park Royal in terms of street-facing activity, they frequently fail to provide to a minimum effective width allowing passage by all users.

Figure 4-9: Frequently blocked footways (L31)

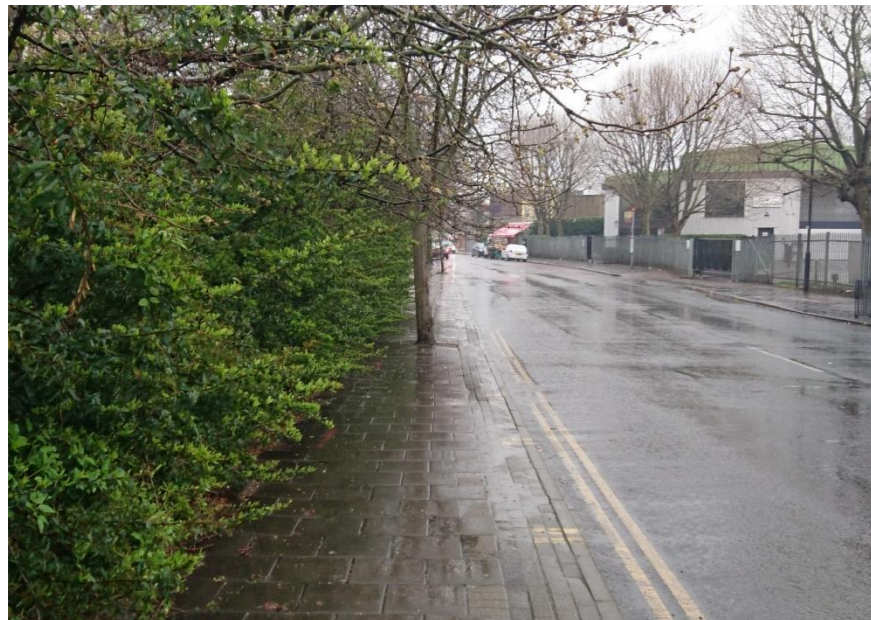
4.2.7 One section of footway adjacent to Central Middlesex Hospital (L34) is effectively blocked by overhanging vegetation. The remaining footway width is unacceptable, especially for an approach route to a major hospital.

**Figure 4-10: Overhanging vegetation (L34)**

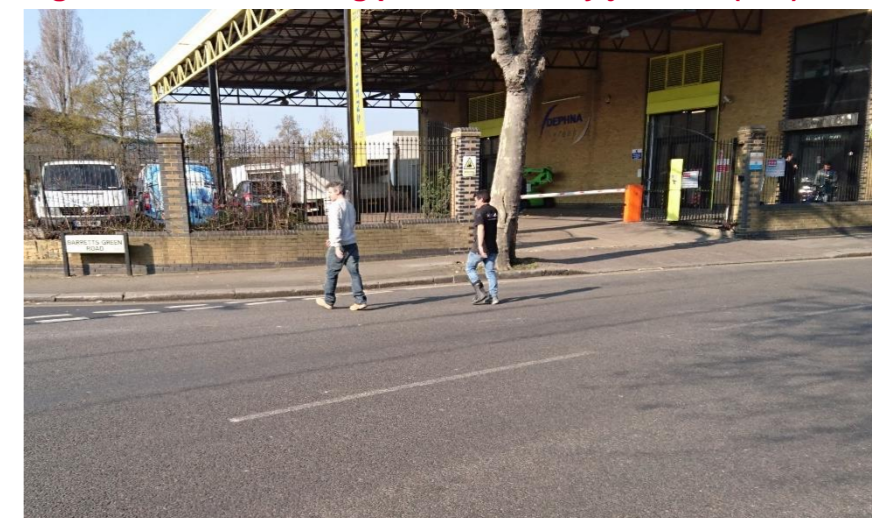
**Figure 4-13: No crossing provision at key junction (L27)**

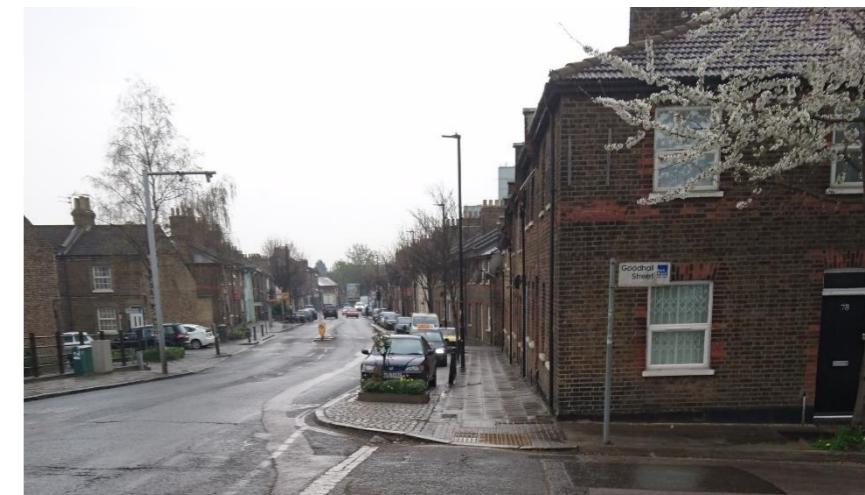
Figure 4-17: Overlooking residential frontages (L7)

4.2.31 In the areas of residential frontage on Old Oak Common Lane (L7), the co-existence of on-street parking and a clear footway is well-managed.

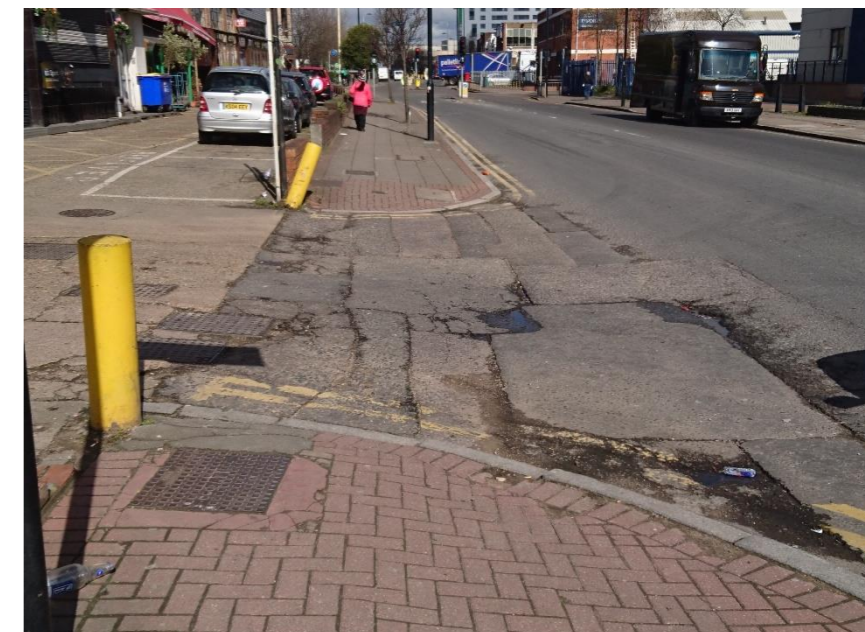
4.2.26 A number of links scored very poorly for surface quality (L20, L23 and L26). Typical evidence of HGV damage includes dislodged kerbstones, surface rutting, cracked paving, cracked or splintering carriageway surfaces on vehicle crossovers. These factors can result in significant trip hazards for pedestrians.

Figure 4-18: Poor surface quality at vehicle crossover (L23)

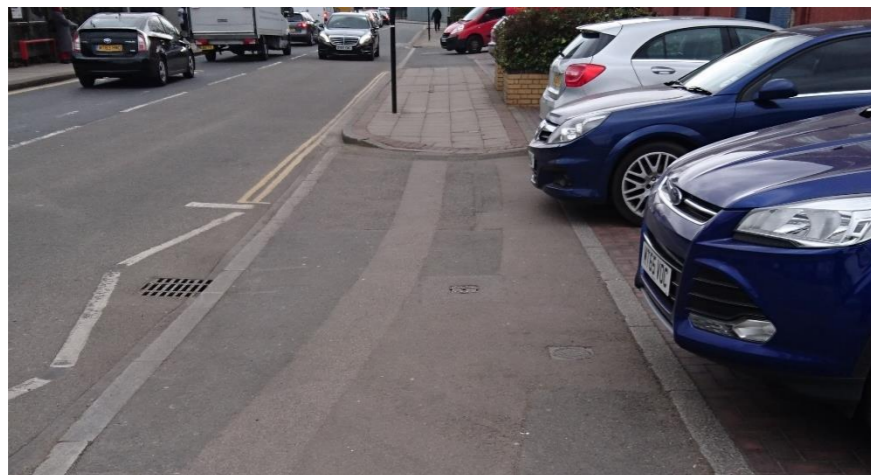
**Figure 4-19: Example of better surface at crossover(L25)**

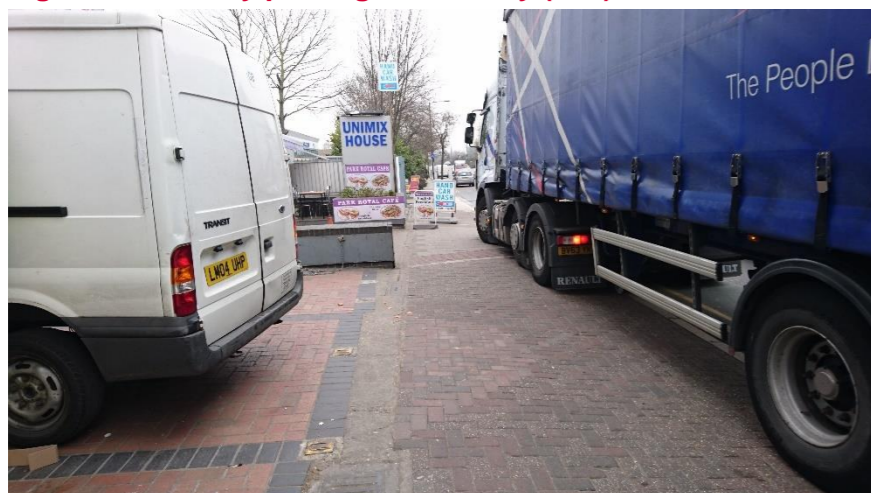
**Figure 4-20: Lorry parking on footway (L35)**

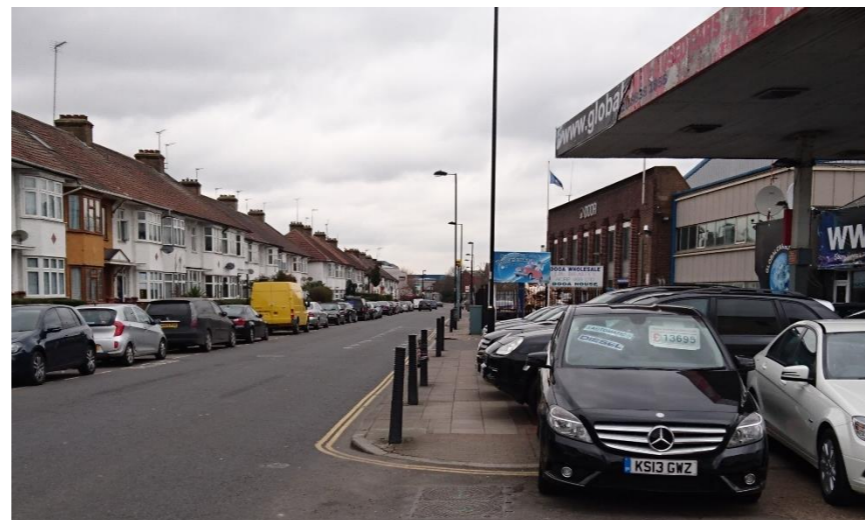
**Figure 4-21: Garage overspill into footway (L24)**

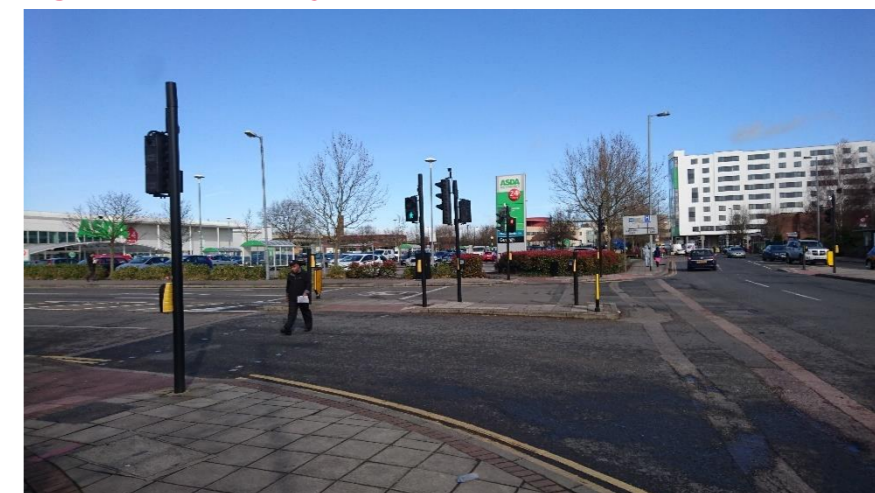
**Figure 4-24: Park Royal 'town centre' (L33)**

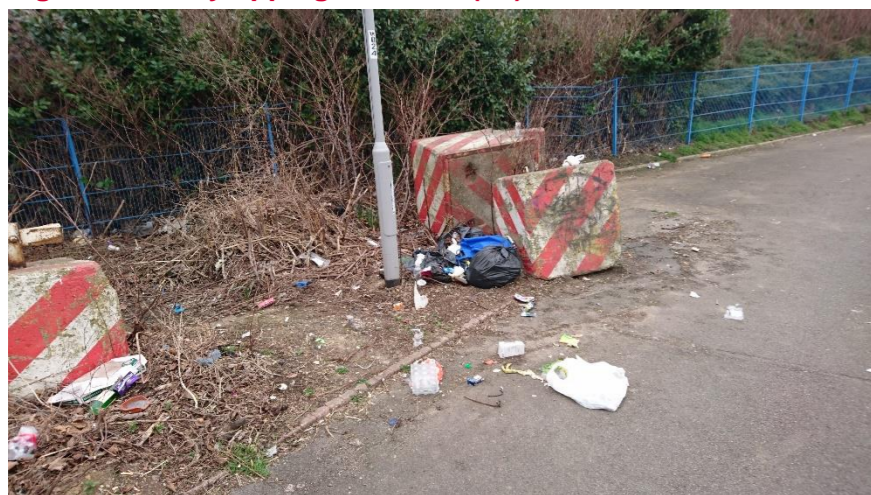
- 4.2.35 A number of both positive and negative scores were allocated to links in the study area for maintenance.
- 4.2.36 The presence of HGVs carrying aggregates through the area means that some streets are frequently exposed to dust, grit and debris. The ability of the footways to be cleaned then depends greatly on the surface quality and the presence of obstruction such as excess guardrail where dirt and grit tends to build up.
- 4.2.37 One observed effect of HGV damage on footways was a tendency for puddling in wet conditions.
- 4.2.38 In terms of general litter, some links were observed to be generally clean with bins generally provided at bus stops. But at the other end of the extreme were links with excessive litter and fly tipping.

**Figure 4-25: Fly tipping and litter (L9)**

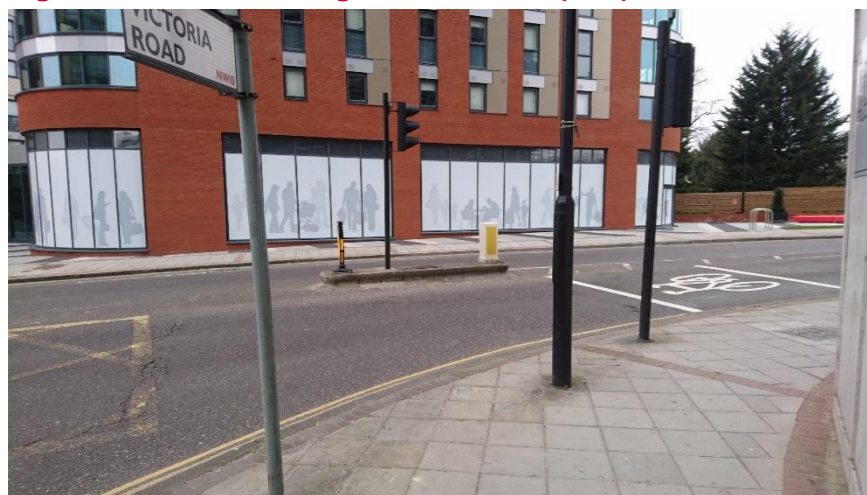
4.3.4 A score of -3 is registered in locations where no crossing is provided on a key pedestrian desire line. For example, there is no crossing on the northern arm of the junction of Victoria Road and Chase Road (nor on the other side of the railway bridge near the start of the cemetery link to Park Royal Road). This means that there is no provision to assist pedestrians across Chase Road on one of the main desire lines to/from North Acton station.

**Figure 4-28: No crossing on desire line (C17)**

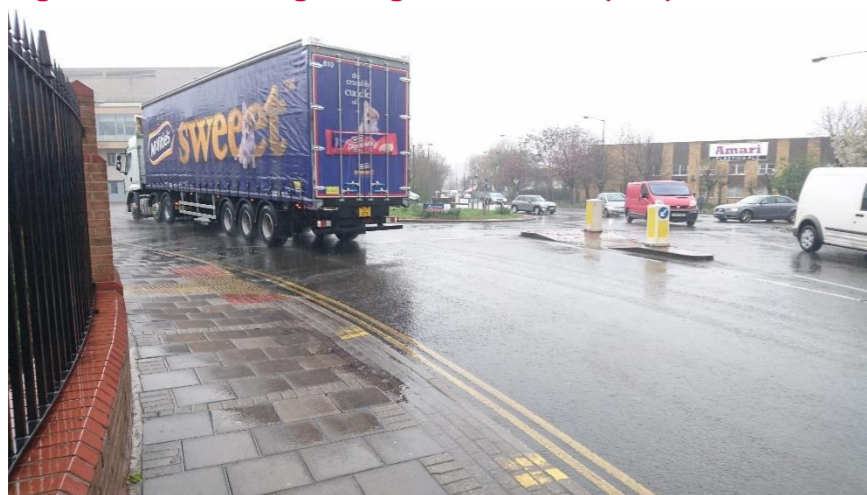
4.3.5 There are several large roundabouts in the study area, one at the entry to Coronation Road (C13 and C40) and two on Abbey Road (C50-C52 and C57-C59). The provision of dropped kerbs is all that denotes a crossing alignment on dual carriageway approaches to these major roundabouts. With wide turning radii, traffic is observed to enter and exit the roundabout at considerable speed.

**Figure 4-29: Crossing at large roundabout (C52)**

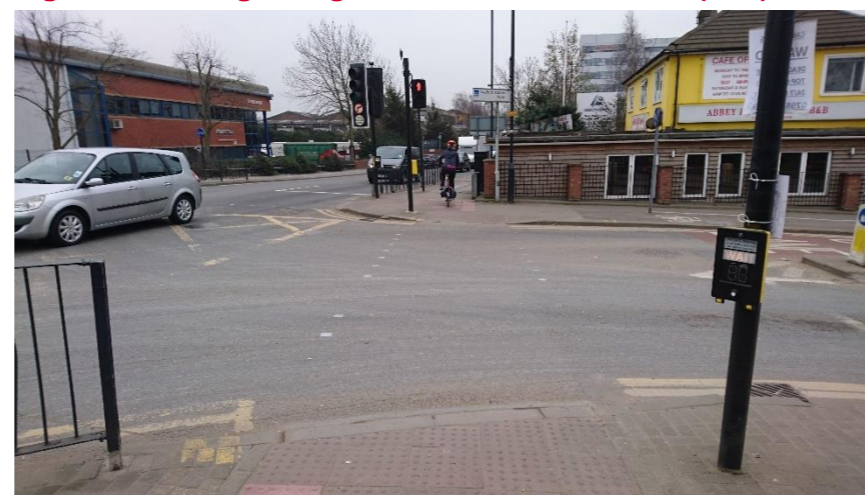
**Figure 4-31: Single stage on the main desire line (C55)**

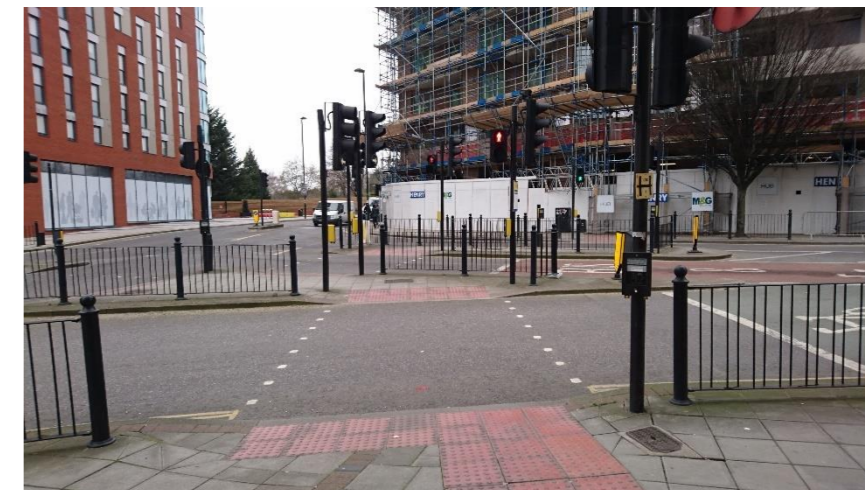
4.3.8 In addition to the locations where there is no crossing provided on the pedestrian desire line, several crossings were highlighted as deviating from the desire line due to excessive staggers. For example, there is a triple staggered crossing on the eastern arm of the junction of Victoria Road and Chase Road (C18), which even includes a separate crossing stage for a bus-only right-turn slip used by a single bus route.

**Figure 4-32: Triple staggered crossing (C18)**

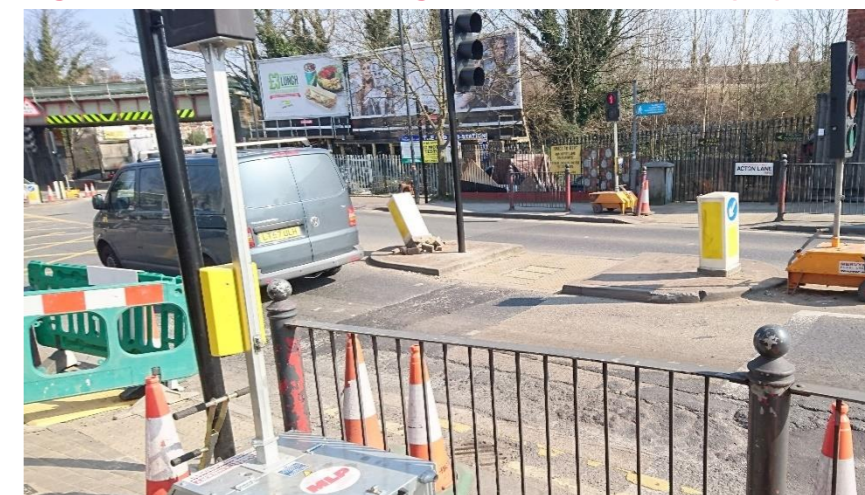
**Figure 4-33: Narrow crossing at Harlesden station (C8)**

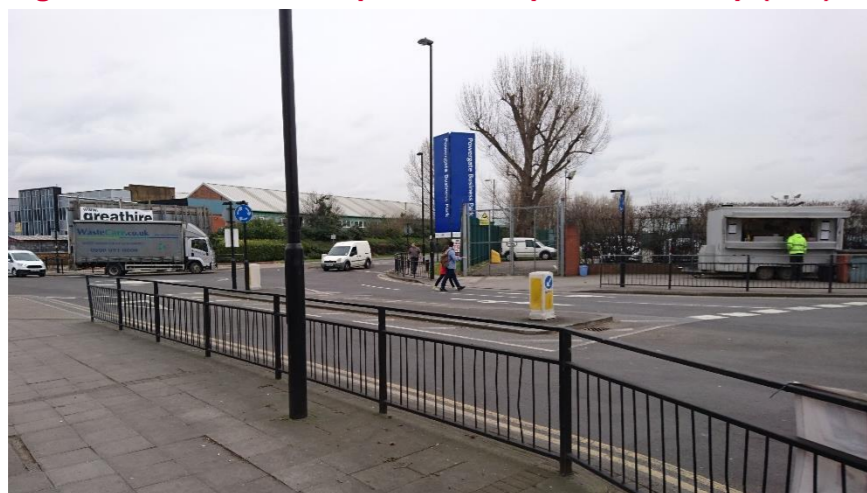
4.3.15 The roundabouts do not perform as well in terms of the delineation of pedestrian crossing space and sightlines between drivers and pedestrians. In many cases there is simply very little sense of pedestrian ownership of the space. The double roundabout arrangement on Chase Road is one example of illegible crossings. Drivers are observed to approach at speed and negotiate between multiple vehicle movements while paying little attention to the presence of pedestrians.

**Figure 4-34: No sense of pedestrian space ownership (C23)**

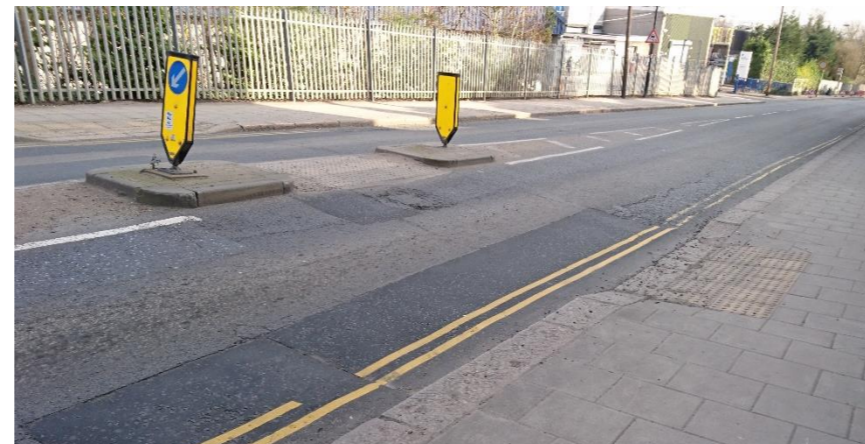
4.3.19 Surface quality issues occur at several points where the carriageway is uneven, rutted or broken up at the point where pedestrian cross the road (e.g. C20 and C22).

**Figure 4-35: Carriageway damage at crossing (C22)**

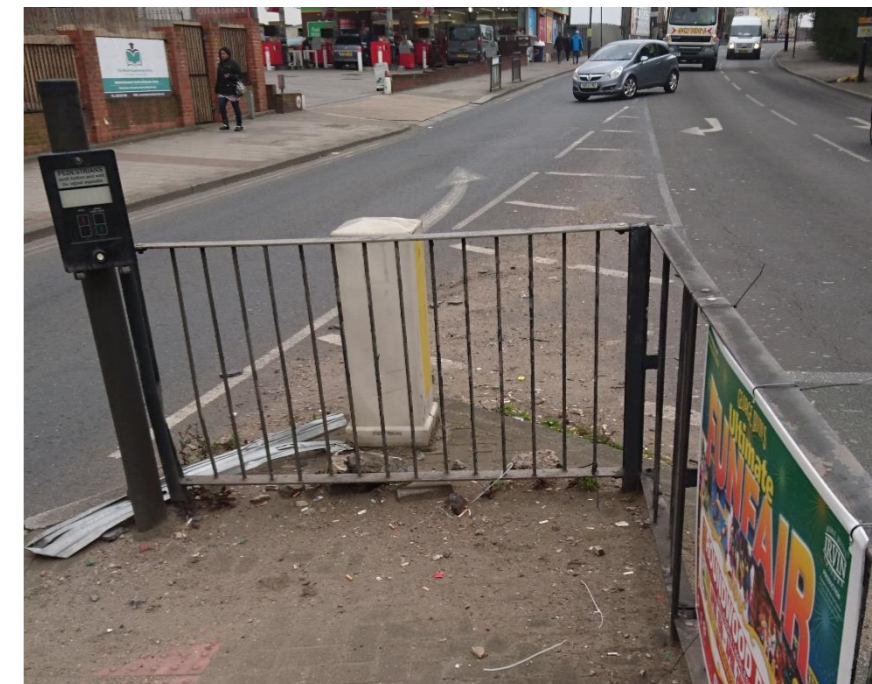
4.3.20 It was identified in the link audits that the presence of HGVs transporting aggregates results in grit and dust in the carriageway. This grit and debris tends to gather at dropped kerbs and crossing islands.

**Figure 4-36: Build-up of grit and debris at crossing island (C7)**

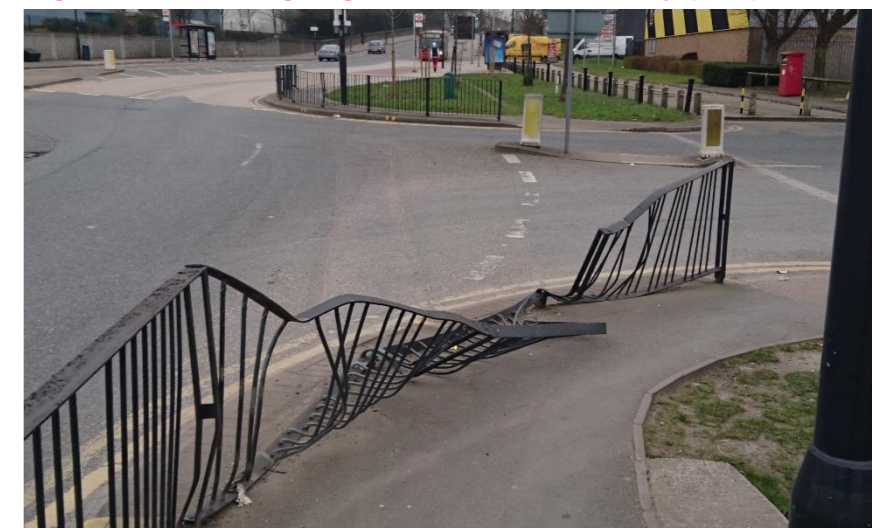
4.3.21 One specific issue noted in the study area is the frequent presence of guard rail and other street furniture that has been damaged by vehicles. This may be a consequence of the aggressive driving behaviour frequently observed in the area and it does reduce the effective pedestrian width available in several places (C13 and C58).

**Figure 4-37: Damaged guard rail in the footway (C58)**
