Detailed UXO Risk Assessment

FIL Reference: 2663R

Project: Keir Hardie Way, Barking

Site Location: Keir Hardie Way, Barking, IG11 9NX

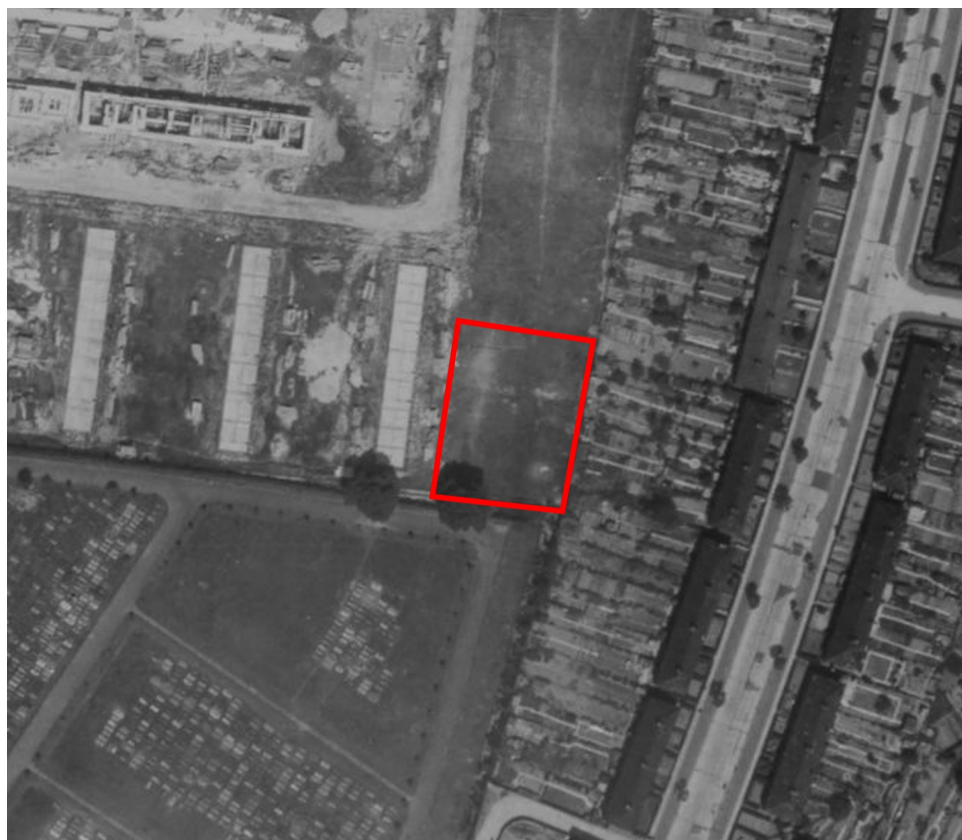
Figure 3. A 1946 dated aerial photograph showing the site as open ground.

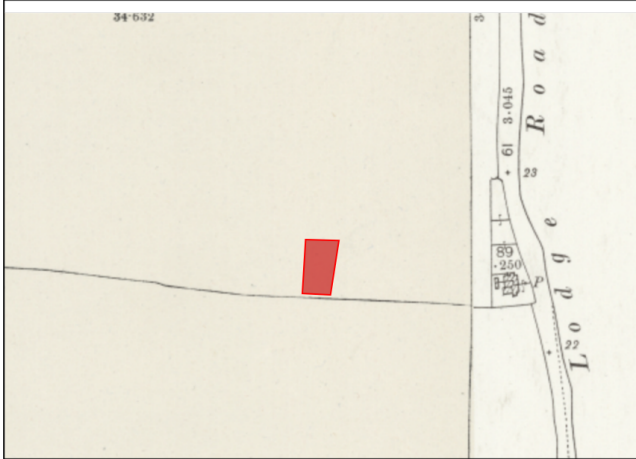
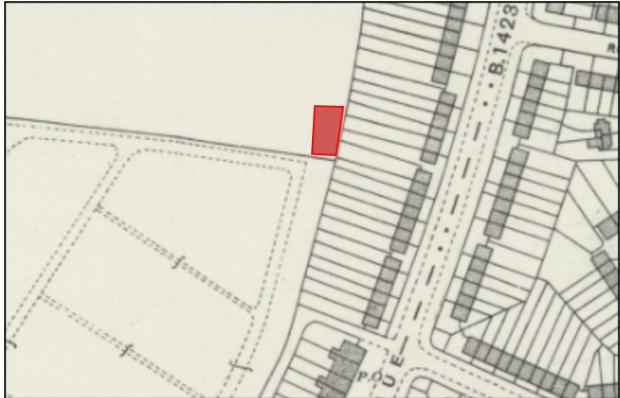
<p>Showing a section of 1892 OS mapping. The site occupies a section of open ground west of Lodge Road, later renamed Lodge Avenue.</p>	<p>Showing a section of the 1938 revision of OS mapping. The site occupies a section of open ground with residential properties visible along the eastern site border. This was the site's wartime composition.</p>

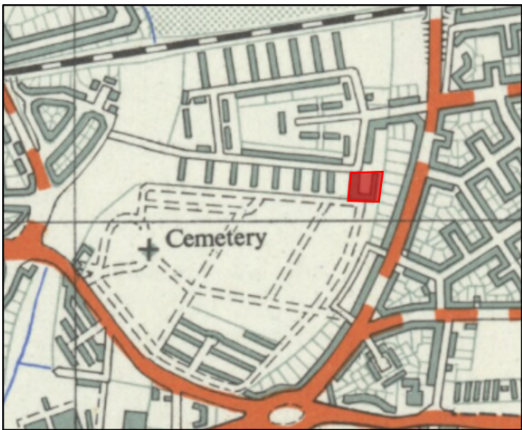
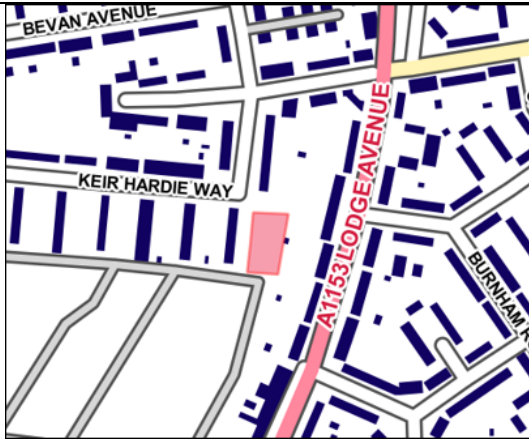
<p>Showing a section of the 1959 revision of OS mapping. The site and surrounding area have been built up during the intervening post-war period.</p>	<p>Showing a section of the 2020 revision of OS mapping, detailing the location of the site. Post-war development is evident in the area surrounding the site.</p>

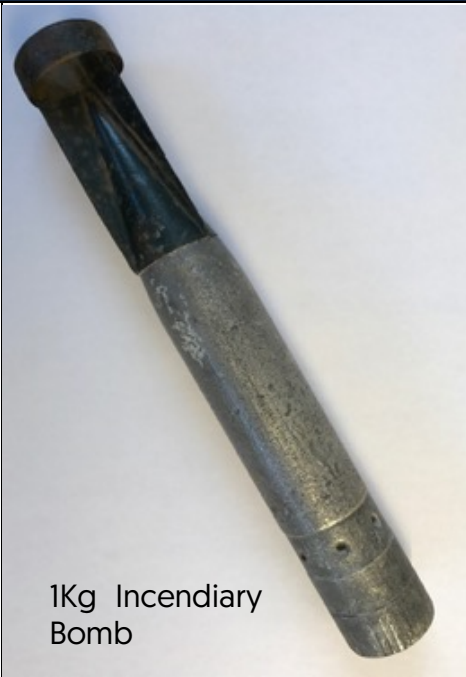
<p>1Kg Incendiary Bomb</p>	<p>The 1 kg B1E incendiary bomb consisted of a cylinder of magnesium alloy, with an incendiary filling of thermite. Rivetted to the body was a steel tail with three fins. These bombs did not explode but were ignited by a small percussion charge, fired upon impact. They were dropped in a variety of containers. Later an explosive head was incorporated into the IB.</p>

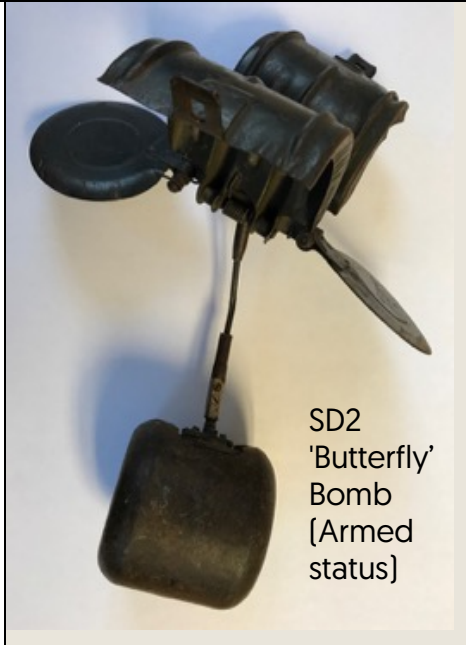
<p>SD2 'Butterfly' Bomb [Armed status]</p>	<p>A Butterfly Bomb (or <i>Sprengbombe Dickwandig</i> 2kg or SD2) was a German 2-kilogram anti-personnel sub munition used by the Luftwaffe during the Second World War. It was so named because the thin cylindrical metal outer shell which hinged open when the bomblet deployed gave it the superficial appearance of a large butterfly. The design was very distinctive and easy to recognise. SD2 bomblets were not dropped individually but were packed into containers holding between 6 and 108 sub munitions. These broke open in air and scattered the sub-munitions.</p>

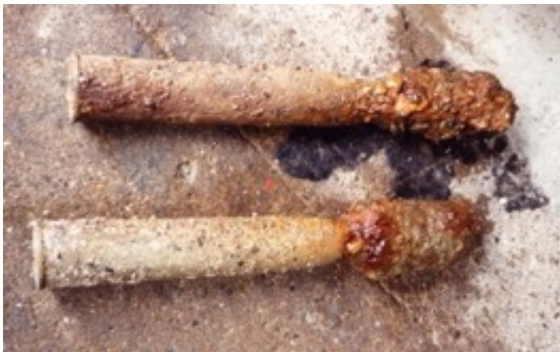
40mm AA Shells found at W Sussex site	Fixed [Heavy] Anti-Aircraft batteries were set up all around the country to defend potential targets from aerial attack. Size of guns and shells ranged from small, quick-firing 40mm Bofors guns to larger 3.7 or 4.5inch guns. 3.7 Inch = 12.7kg 94mm x 438mm 40mm = 0.9kg 40mm x 311mm 4.5 Inch = 24.7kg 114mm x 578mm

HAA projectiles were high explosive shells, usually fitted with a time delay or a barometric pressure fuze to make them explode at a pre-determined height. If they failed to explode or strike an aircraft, they would eventually descend back to earth.
