**LAND AT GORESBROOK ROAD,
DAGENHAM, RM9 6XS
PHASE I AND PHASE II
GEOTECHNICAL AND GEO-
ENVIRONMENTAL GROUND
INVESTIGATION REPORT
BEFIRST (REGENERATION) LTD
29TH OCTOBER 2020**

Site:	LAND AT GOESBROOK ROAD, DAGENHAM, RM9 6XS	
Title:	PHASE I AND PHASE II GEOTECHNICAL AND GEO-ENVIRONMENTAL GROUND INVESTIGATION	
Project:	RESIDENTIAL DEVELOPMENT	
Client:	BEFIRST (REGENERATION) LTD.	
Date:	29 TH OCTOBER 2020	
Reference:	LS 4745	
Version:	V1.0	
Prepared by:

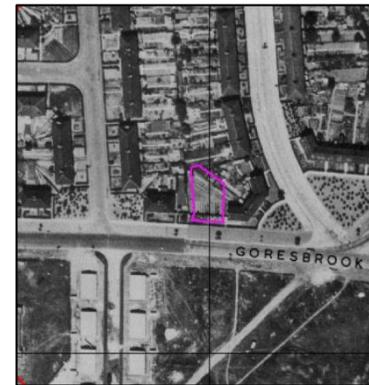
OS Map 1947

Aerial photographs dating between 1947 and 2020 available online and within the Envirocheck report were also reviewed. The early image indicates primarily residential land use with new buildings being built to the southwest. By 1999 the north of the site remains primarily residential whilst school and building works are noted south of the site beyond Goresbrook Road. Former houses noted in 1945 are no longer mapped and a sports centre is now present.

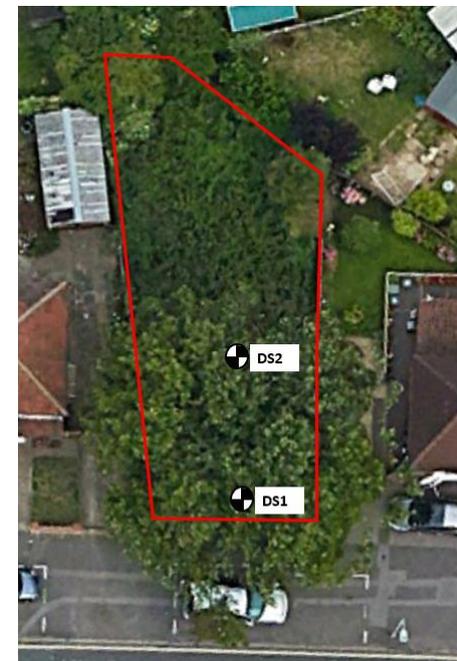
A site plan showing the investigation layout is presented below. This has also been appended to the end of the report as shown in Figure 2.
