# Public Realm, Walking and Cycling Strategy

## APPENDIX 4

**Old Oak & Park Royal Walking, Cycling, Streets and Public Realm Strategy: PERS audit**

April 2017

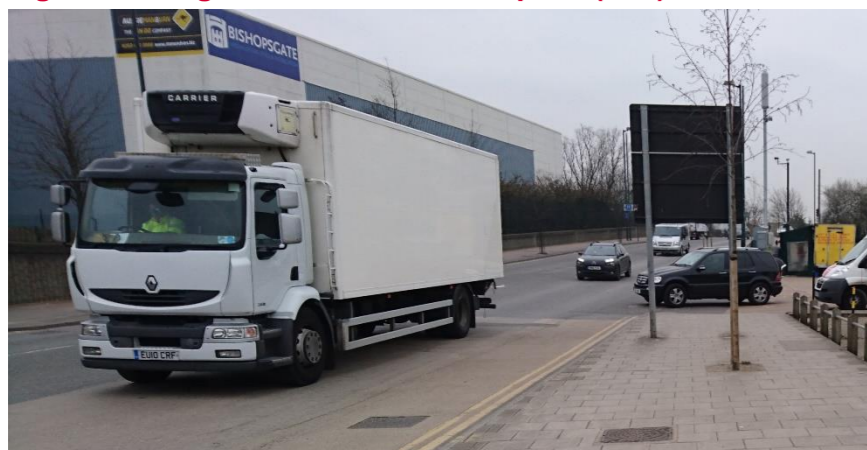
4.1.4 Several of the main routes into the study area are characterised by their high volume and speed of traffic. The provision of pedestrian crossing facilities is mixed. While there are some junctions where signalised pedestrian crossings are provided, there are also several examples of large roundabouts where pedestrians need to cross multiple lanes of traffic, often exiting the roundabout at speed. There are also key junctions where there is absolutely no provision

Figure 4-2: High traffic volume and speed (R9a)

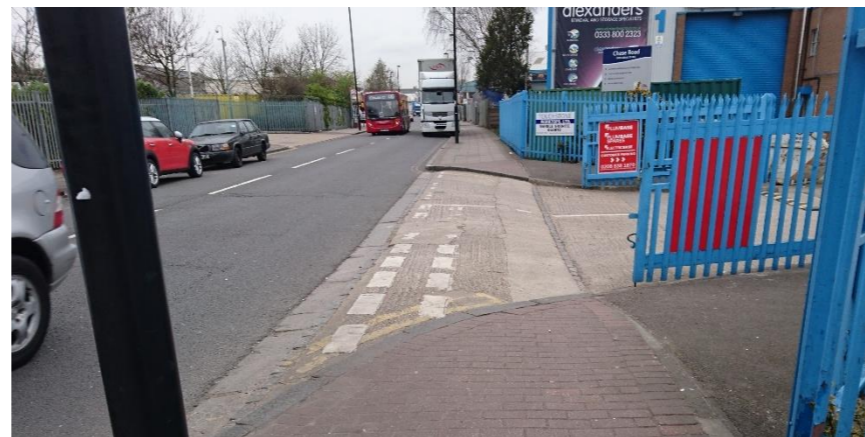
4.2.9 The study area also includes a number of links where the basic minimum of a continuous step-free footway along the main routes the area is not achieved. This is generally as a result of vehicle crossover arrangements to access industrial units. This is surprising in such an employment area not only because it excludes certain groups from accessing employment in Park Royal but because it also renders some types of servicing more difficult if goods are to be wheeled in by foot from vehicles parked in the street.

**Figure 4-11: Lack of step-free access at crossovers (L20)**

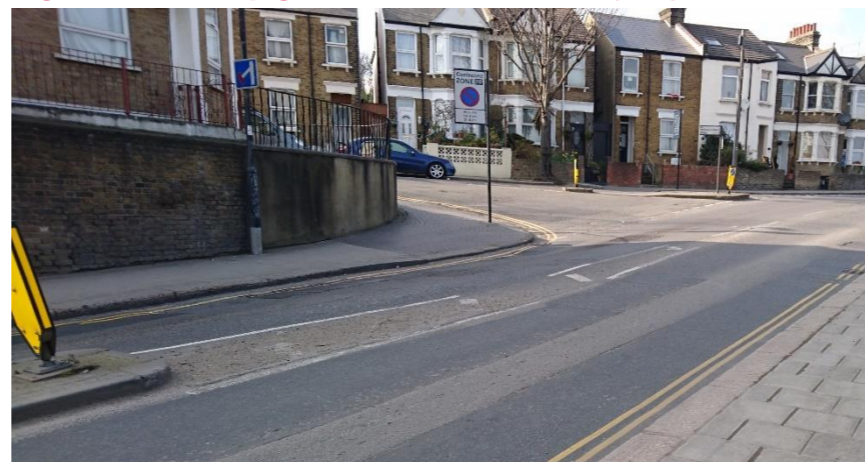
4.2.10 The topography of the study area means that a number of links contain some gradient. In most cases the street network follows continuous gradual gradients. Localised gradient issues in the detail of the pedestrian network can occur where steep dropped kerbs are provided on sections of slight gradient, or for example where the radius of a road junction leads to a tight pedestrian space with steep gradient and crossfall (L19).

**Figure 4-12: Steep gradients with crossfall (L19)**

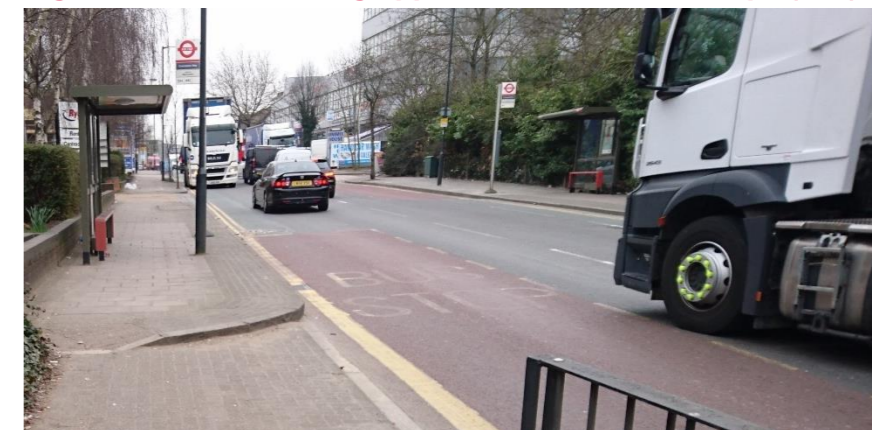
**Figure 4-14: No crossing opportunities near bus stops (L35)**

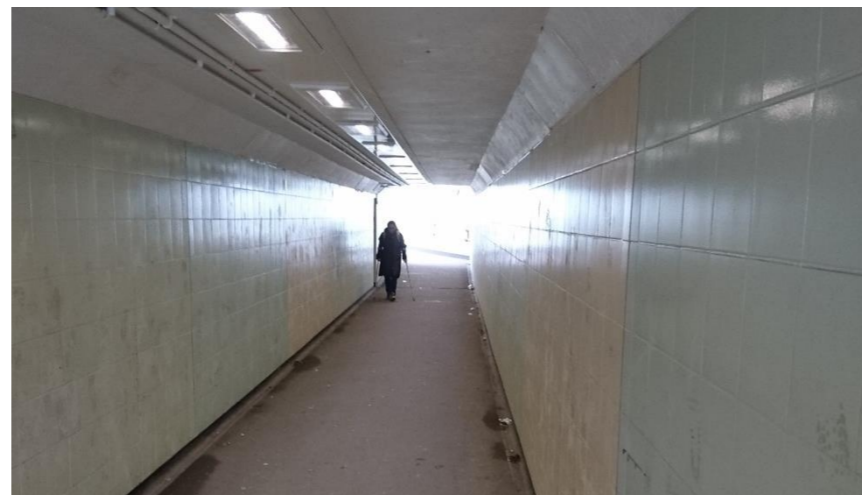
4.2.21 The cemetery link forms the main station access link between North Acton station and Park Royal Road. This link does not have any surveillance from surrounding land uses.

Figure 4-15: Park Royal station link (L11)

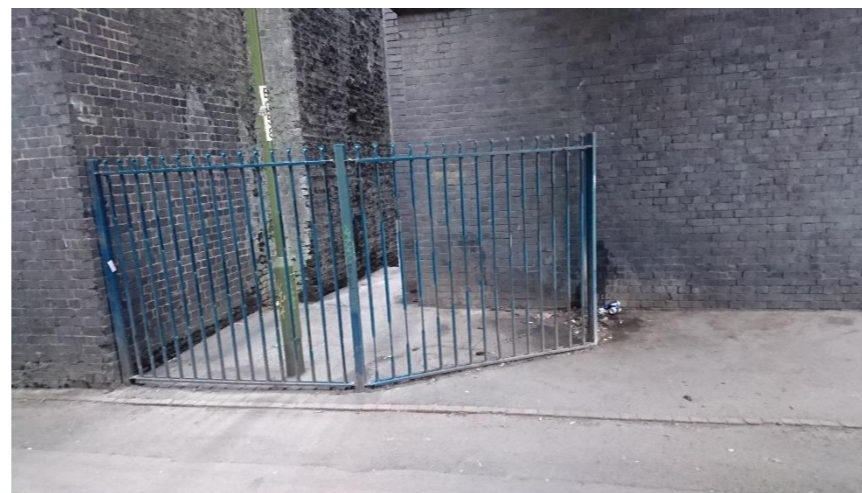
4.2.22 The routes into the study area from East Acton station (L17) and from Stonebridge Park station (L9) include successive railway tunnels. Even with dedicated lighting of the pedestrian space, these tunnels are dark and frequently damp spaces, which often have shadowy concealed spaces around the tunnel arch. In some cases measures have been taken to close off concealed spaces to give more confidence to pedestrians at night.

Figure 4-16: Closing off concealed spaces in tunnel (L9)

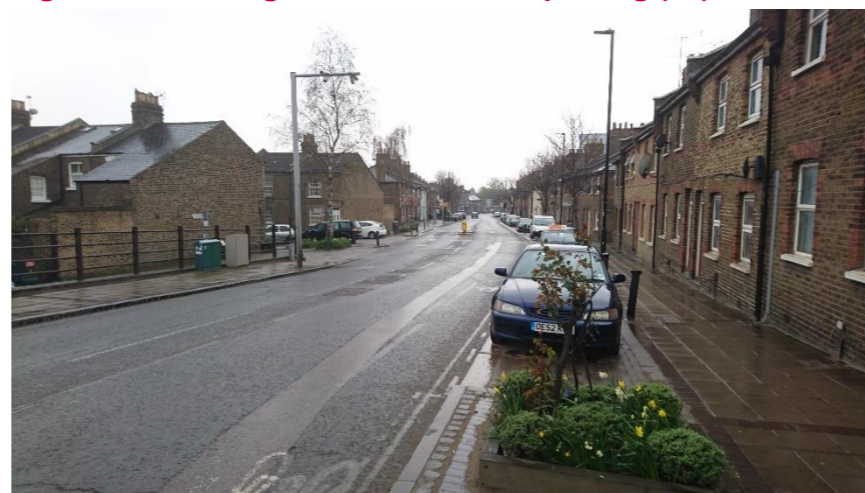
4.2.31 In the areas of residential frontage on Old Oak Common Lane (L7), the co-existence of on-street parking and a clear footway is well-managed.

**Figure 4-22: Management of on-street parking (L7)**

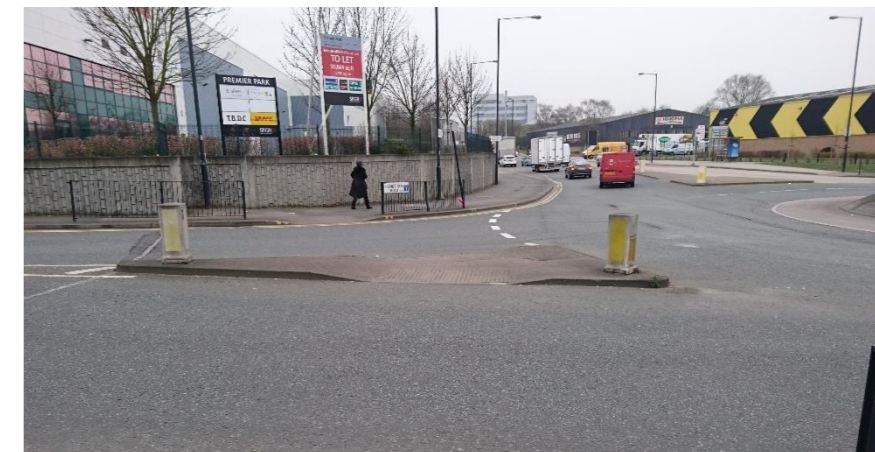
visual interest for pedestrians have the largest unit sizes, which turn their back on these routes (e.g. L36). The links with smaller units and more street-facing activities have a more human scale.

**Figure 4-23: Large unit sizes on Abbey Road (L36)**

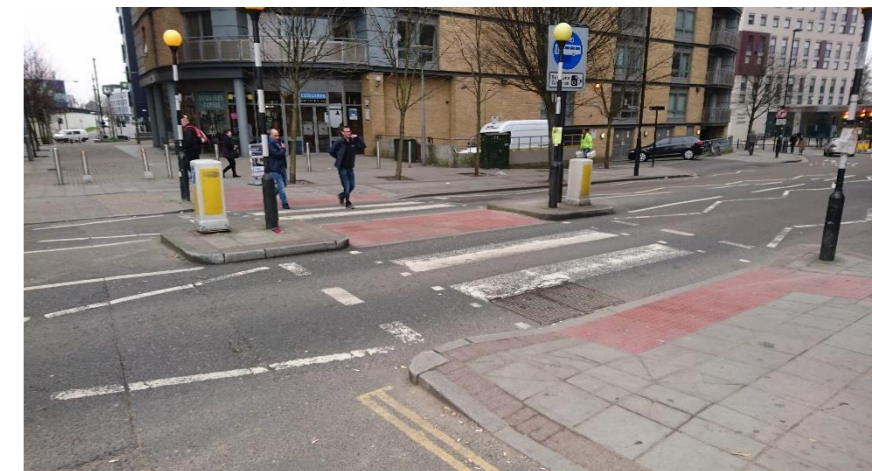
- 4.3.3 A number of the pedestrian crossing facilities are scored highly in terms of provision and performance. This includes the zebra crossing at the entry to North Acton station (C16), which has the capacity to cope well with the regular bursts of pedestrians exiting the Central Line. The signalised junctions on Abbey Road (C60, C61, C54, C55 and C56) also score well since they provide pedestrian-activated and protected crossings on what is a very busy road with high traffic flows.

**Figure 4-27: High capacity zebra crossing (C16)**

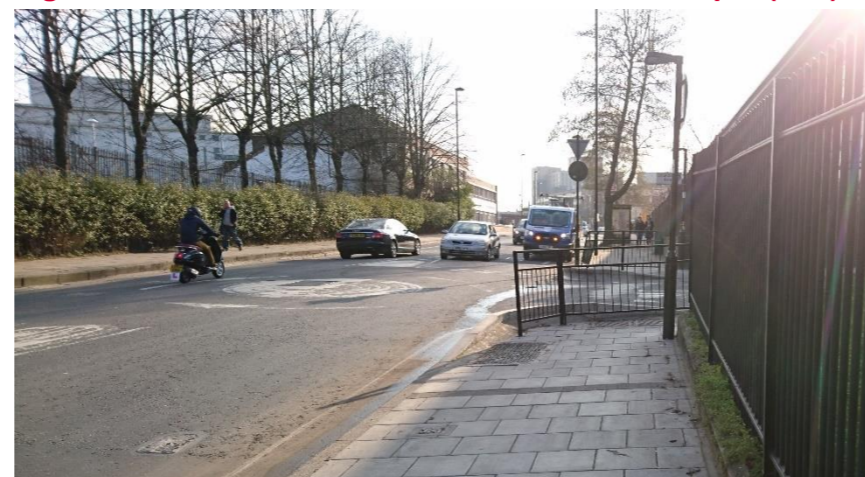
use of a mini-roundabout at this location is appropriate but the layout where pedestrians are forced into the drivers' blind spot to cross is unsatisfactory.

**Figure 4-30: Pedestrians forced to cross in blind spot (C25)**
